February 25, 2021

RE: 123 Autumn Lane - Anytown, CT.

On February 21, 2021 we visited the above referenced location to inspect the foundation of the existing residential structure - specifically the crack(s) noted during a recent home inspection. This inspection was limited to areas of the foundation that were viewable at the time of inspection. The following are our findings:

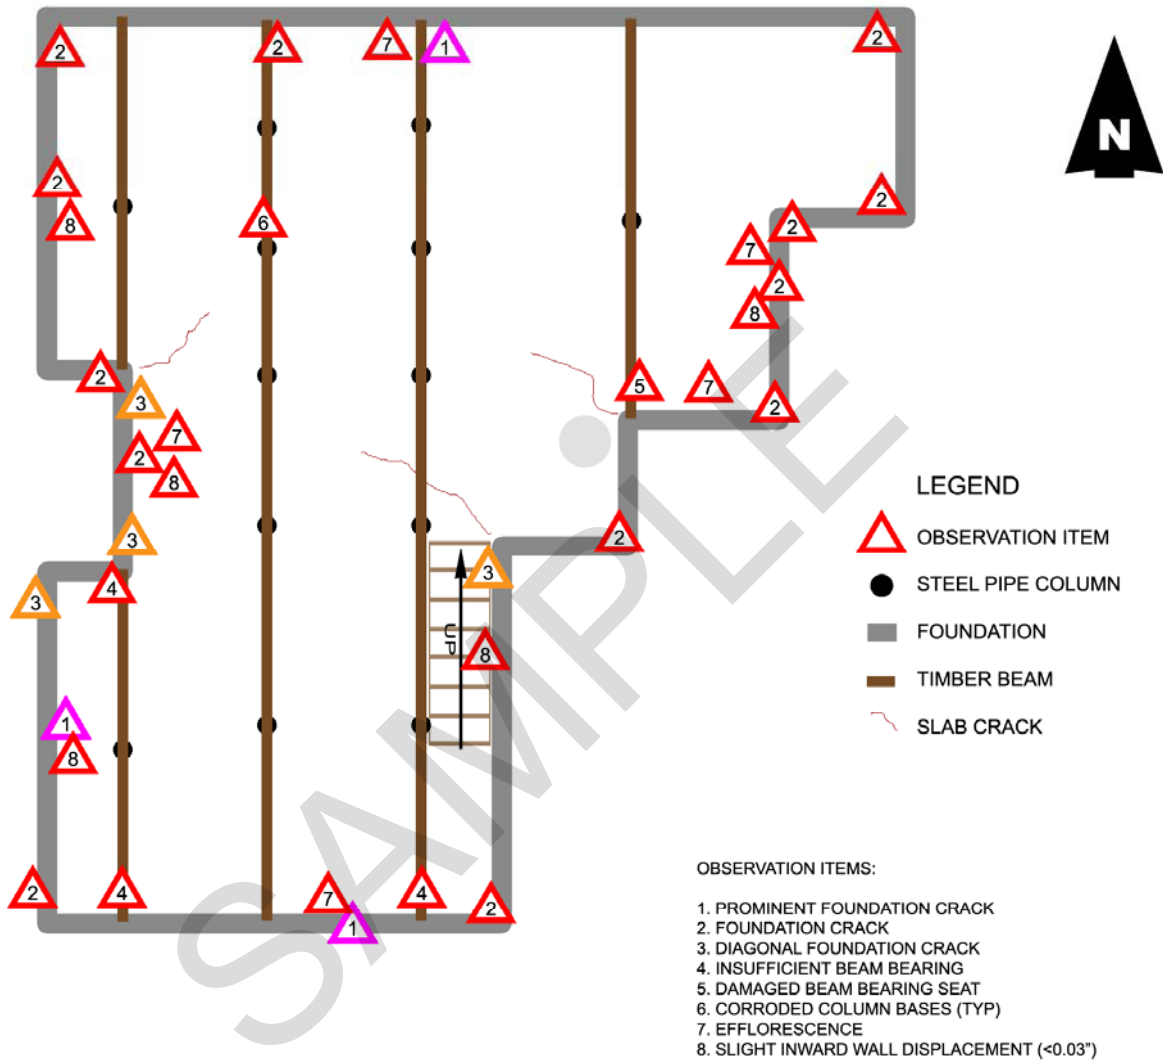
KEY PLAN

On inspection of the foundation walls we observed prominent vertical cracks, (Key Plan Observation Item #1) vertical hairline cracks, (Key Plan Observation Item #2) and diagonal cracks (Key Plan Observation Item #3). These are located on our attached key plan.

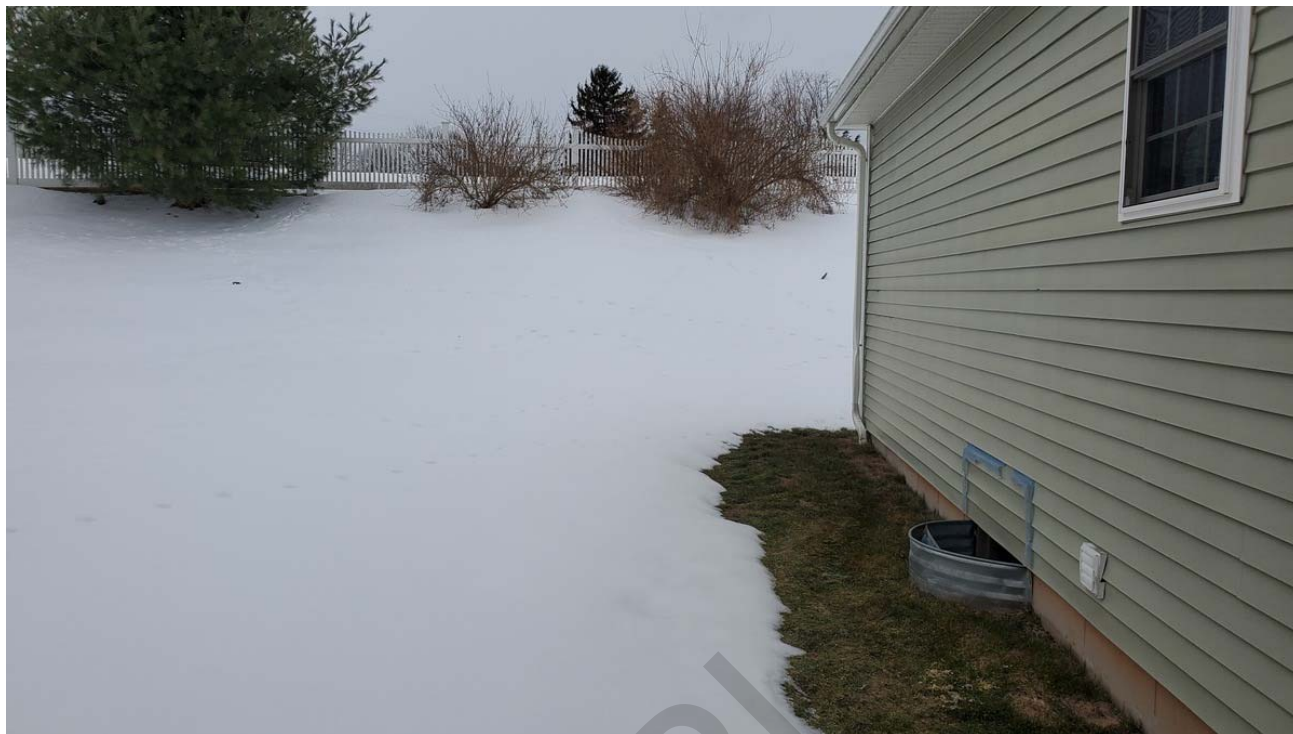
In many areas the grading around this structure is not ideal, low spots exist that may lead water to the foundation. Downspouts have been connected to an underground drainage system. The grade to the west of this structure slopes toward the subject structure. This grade allows water to run off of the surrounding properties and arrive at the west wall of this structure. This water adds weight to the soil which increases the soil force against the foundation, known as hydrostatic pressure.

Grade to the west slopes toward structure.
Drainage system functionality should be verified.

The roof drainage system deposits into an underground system; its functionality should be verified. Proper operation of this system is key to reducing the amount of water arriving at soils surrounding this foundation.

It is unknown if a curtain drain exists surrounding this structure, however we would recommend the verification or installation of a properly designed curtain drain at the west side of this structure which will adequately reduce the amount of water being delivered to the foundation and surrounding soils. Reducing the water in soils surrounding the foundation will reduce hydrostatic pressure against the foundation.

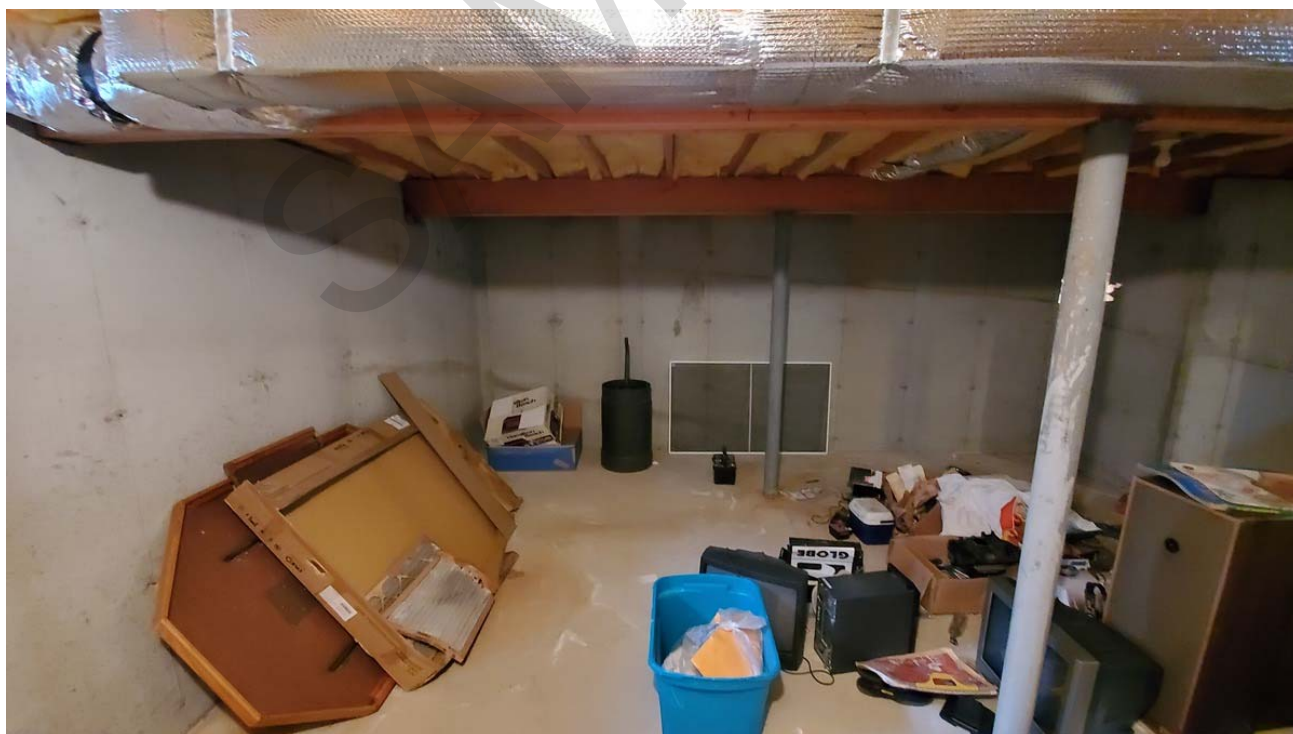
Efflorescence (white salt deposits), an indication of water entry into the basement was observed along the interior of all foundation walls as well as the slab in the southern portion of the basement. (Key Plan Observation Item #7)

Efflorescence and water stains observed on foundation walls and floor slab.

The detection of efflorescence on the basement slab and walls, and slight inward displacement of foundation walls, is an indication that the soils surrounding this structure are becoming inundated with water. Proper site grading to reduce the amount of water standing around the structure is recommended.

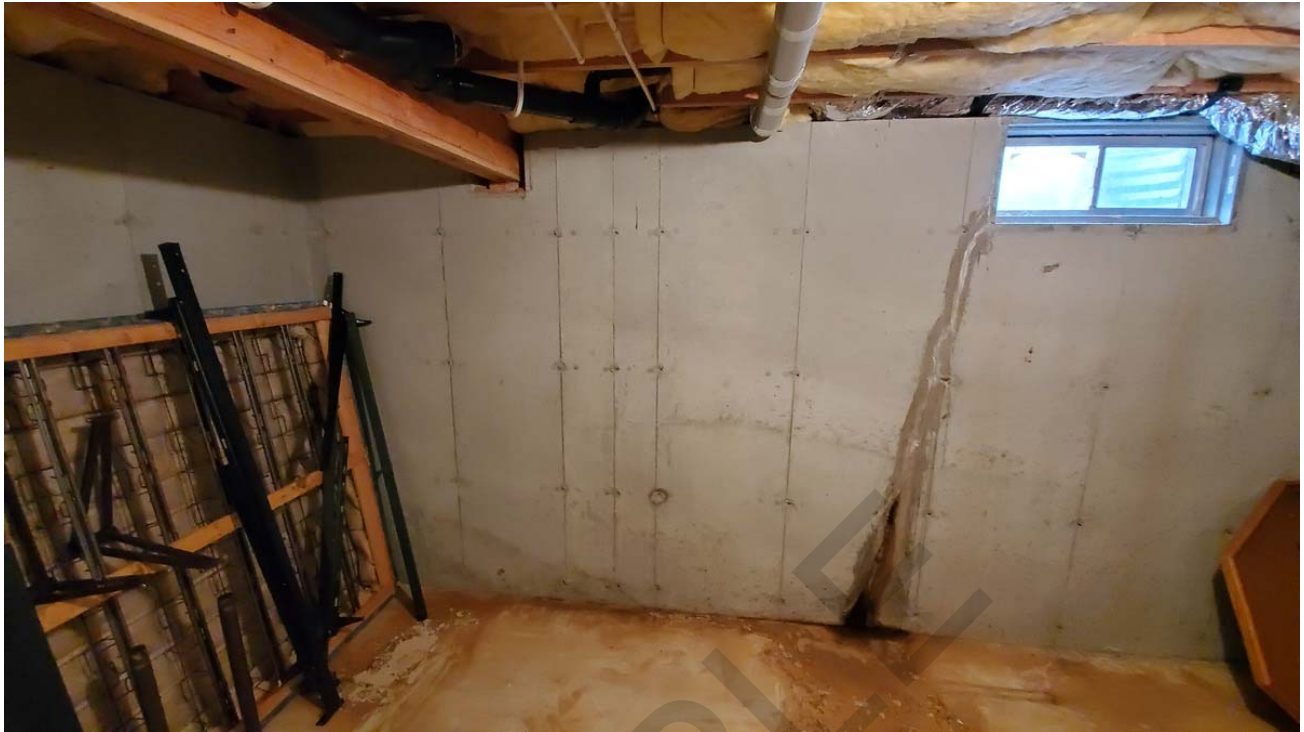
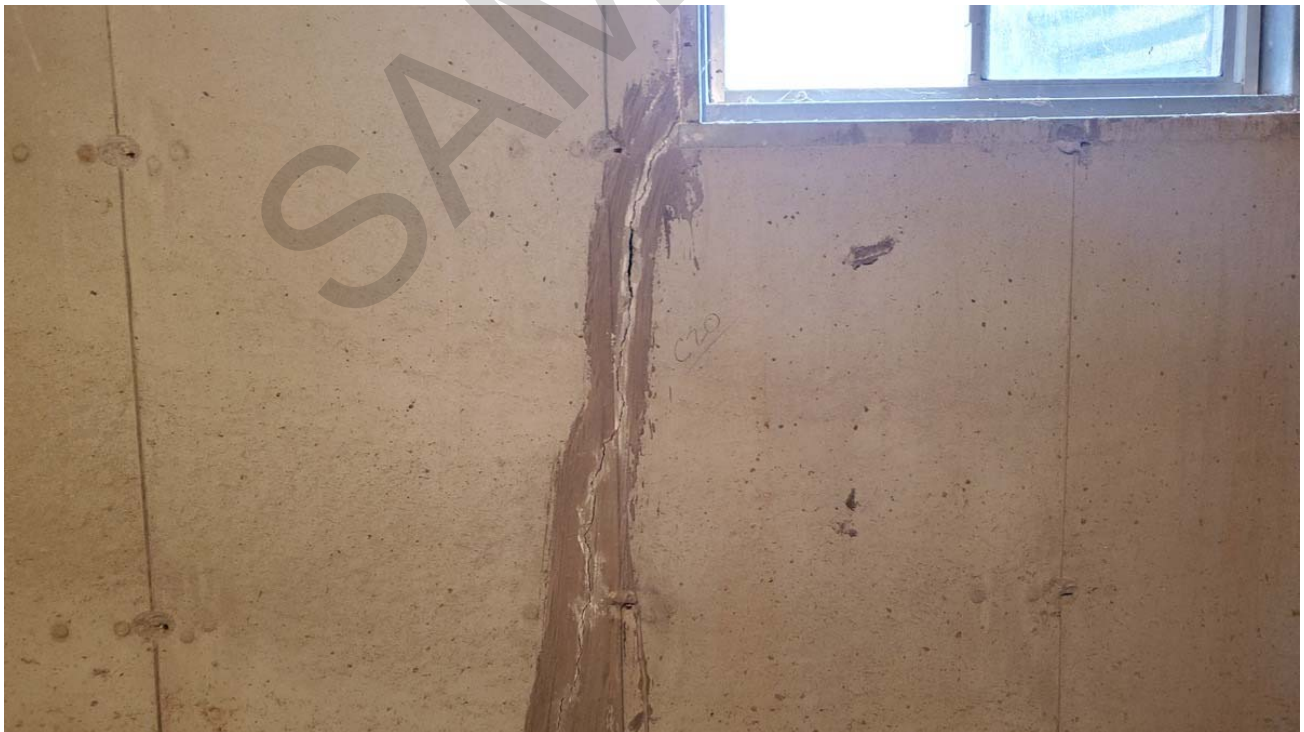
Two of these cracks (located in the north and south foundation walls) are corresponding cracks; they exist at approximately the same point along both the north and south foundation walls. These cracks are tighter at their base, and wider at the top, an indication of minor settlement. A previous attempt was made to cover these cracks with some type of repair material. This material was not applied within the crack, rather was applied at the wall surface only. This repair material is brittle and not well bonded to the concrete, and provides no structural value and will not prevent water entry. This crack repair has begun to cracked again at the crack location since the repair, indicating some small amount of movement has occurred since this repair was made.

Prominent vertical crack in foundation south wall.

Additional view of prominent crack in foundation south wall.

Prominent vertical cracks (greater than 1/16" in width), and all diagonal cracks should be epoxy injected. We recommend using **Sika Sikadur** products. These cracks should then be monitored for future movement, with a recording crack monitor capable of 3-axis recording. Slight cracking of the repair area is expected and can be re-patched, however, should these cracks open significantly (more than 1/8"), or additional displacement is detected, further investigation of this foundation and analysis of the supporting soils will be required.

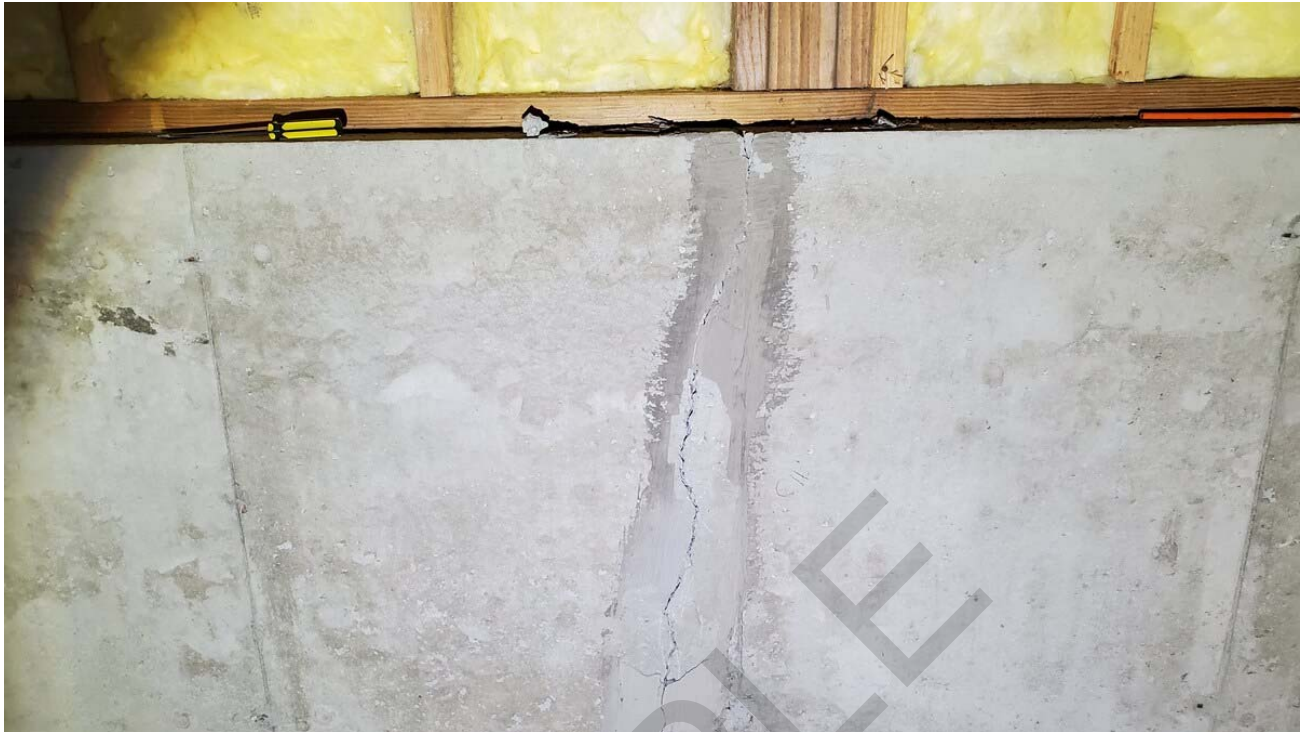
Prominent crack in foundation north wall.

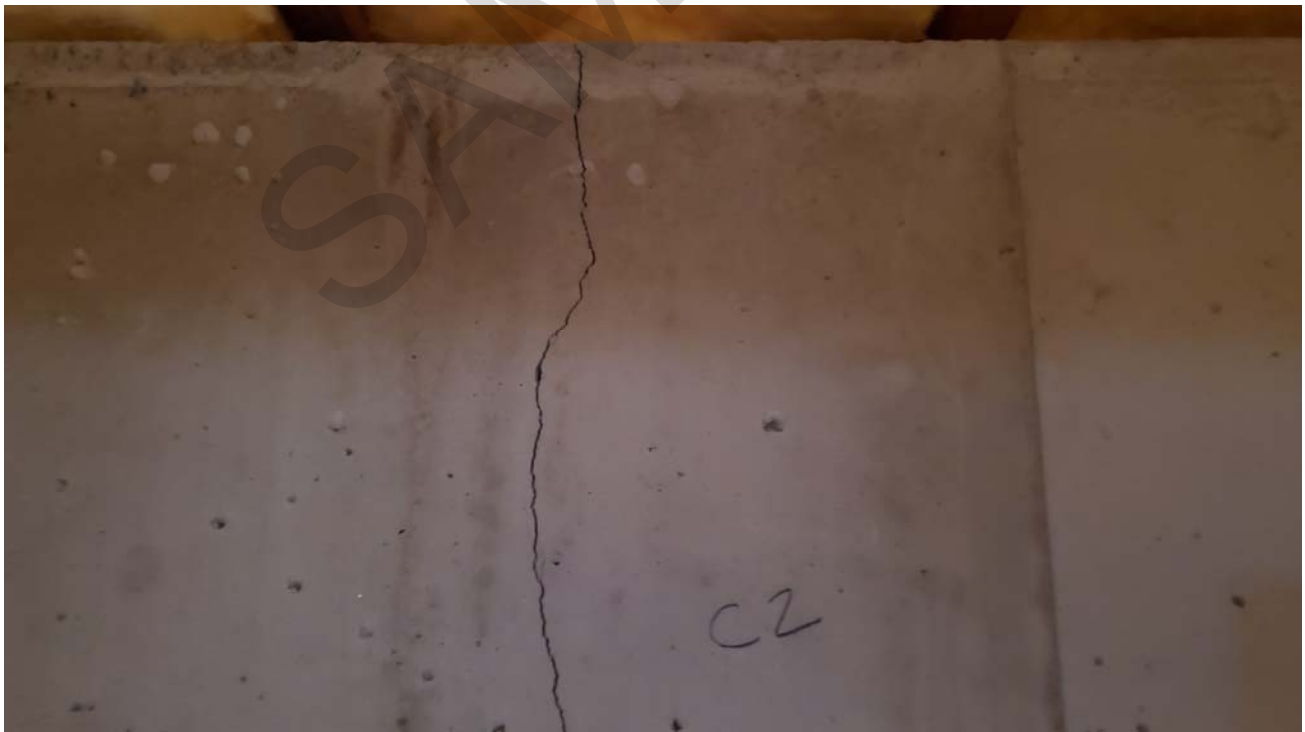
The third prominent vertical crack is located in the west foundation wall. This crack has likely developed as a result of both minor foundation settlements, and hydrostatic soil pressure acting against this foundation wall.

Prominent crack in foundation west wall.

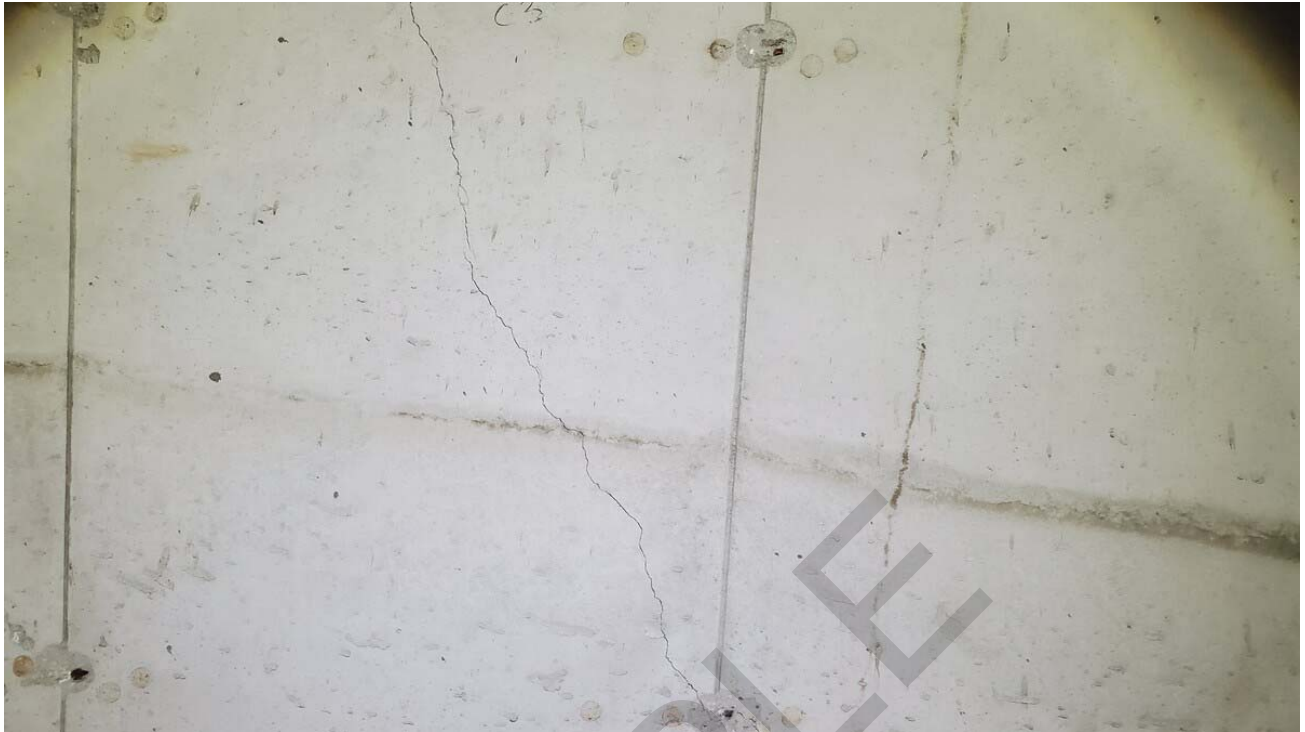
The diagonal cracks along the foundation walls also showed signs of displacement, or inward movement of a section of the foundation wall. (Key Plan Observation Item #8) At the time of the inspection, the observed movement was minimal, with displacement of less than 0.03 of an inch, an indication that site soils have or are exerting hydrostatic pressure on these walls.

Diagonal crack in foundation west wall.

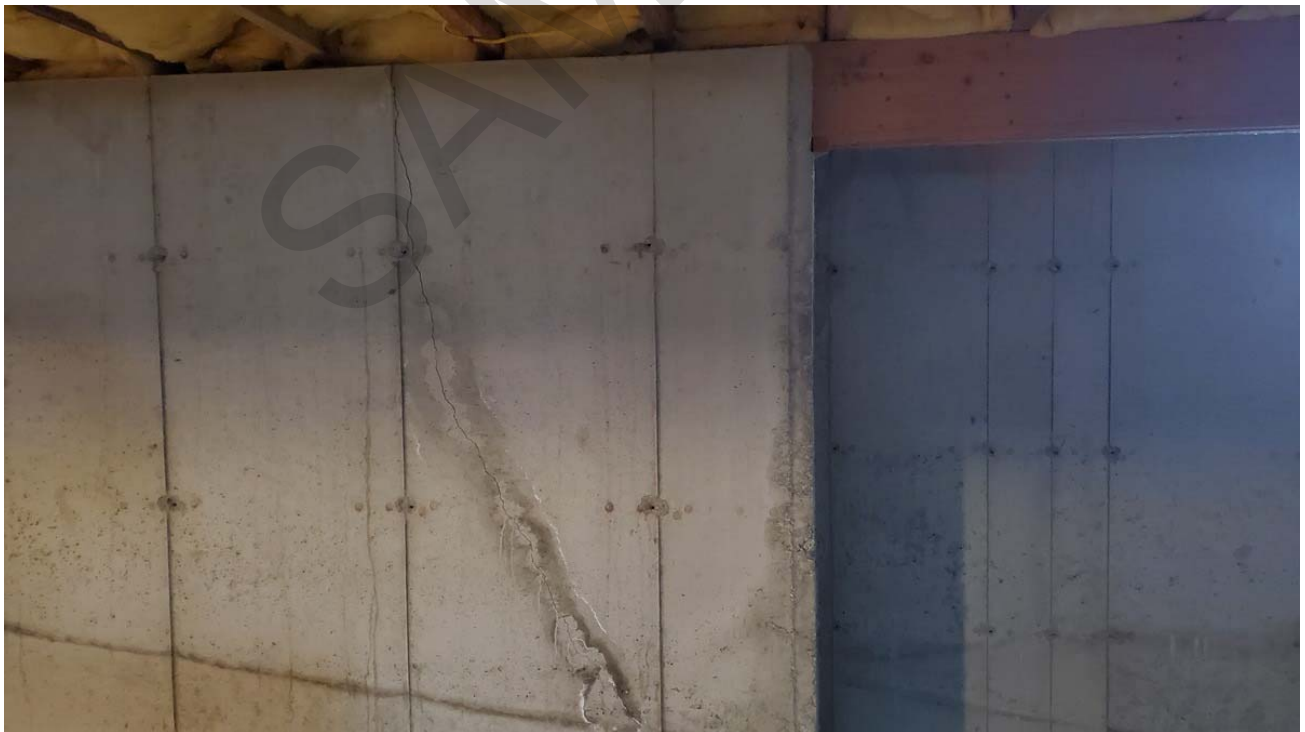
Diagonal crack in foundation west wall, with efflorescence.

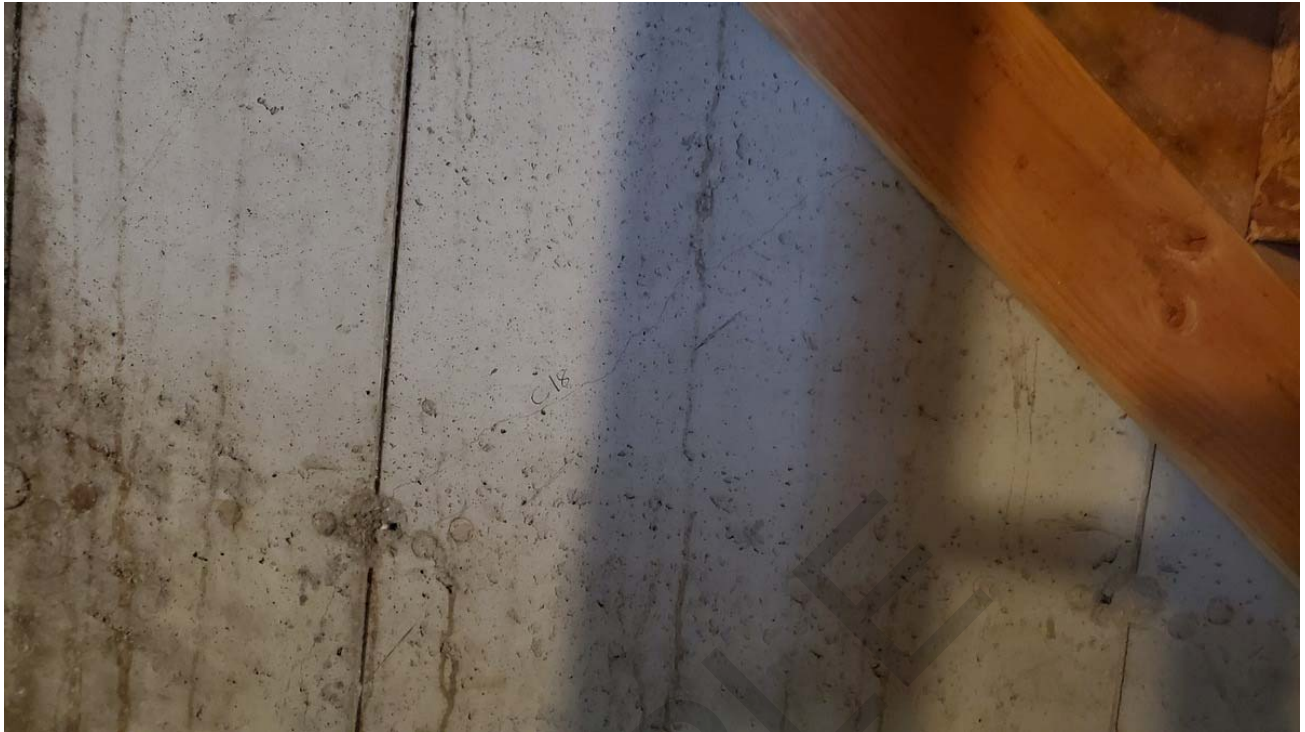
Diagonal crack in foundation east wall.

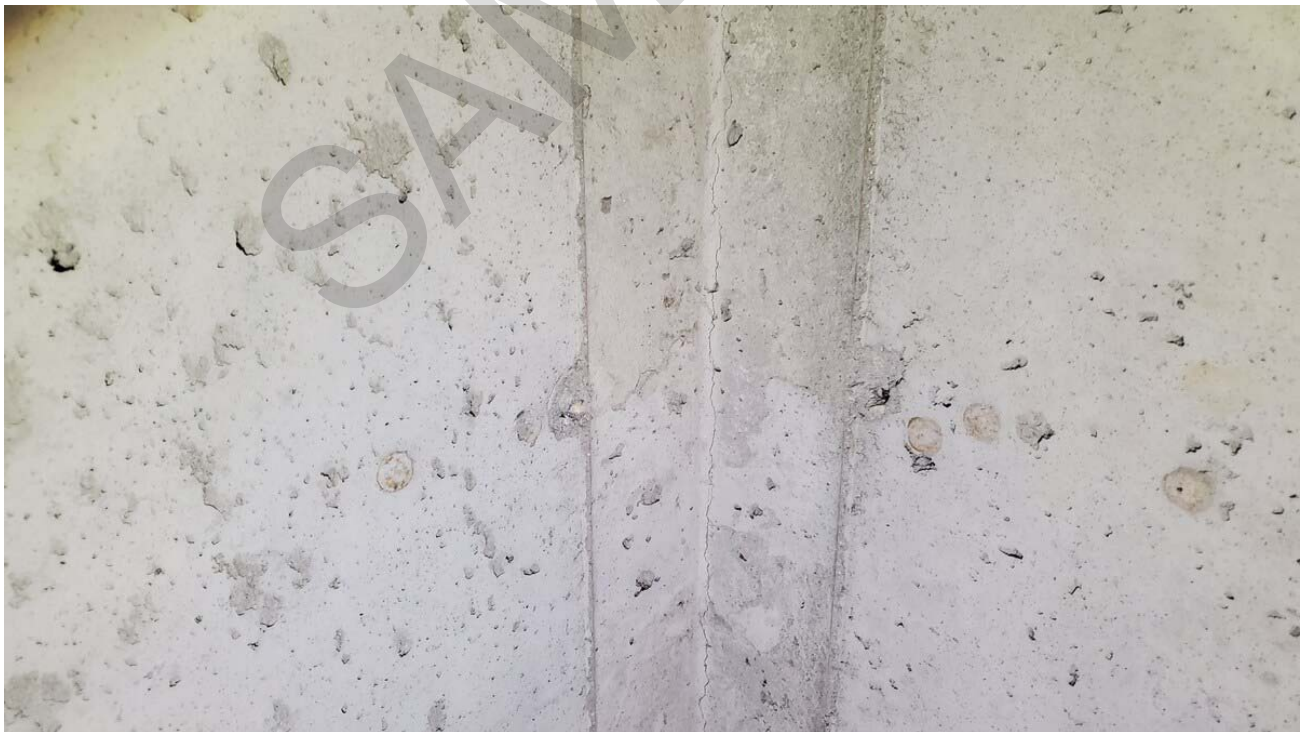
As concrete shrinks during the curing process, vertical cracks form in the concrete, some so small they can hardly be seen. This generally does not affect the basement wall structurally, but could allow moisture to enter if the outside wall's waterproofing isn't flexible enough to span the crack. Often smaller concrete cracks of this type can be caulked or injected with an epoxy to limit further moisture infiltration.

Hairline crack (Typical)

The observed hairline cracks are not a structural issue. These cracks should be monitored for water infiltration, and if present can also be epoxy or urethane injected.

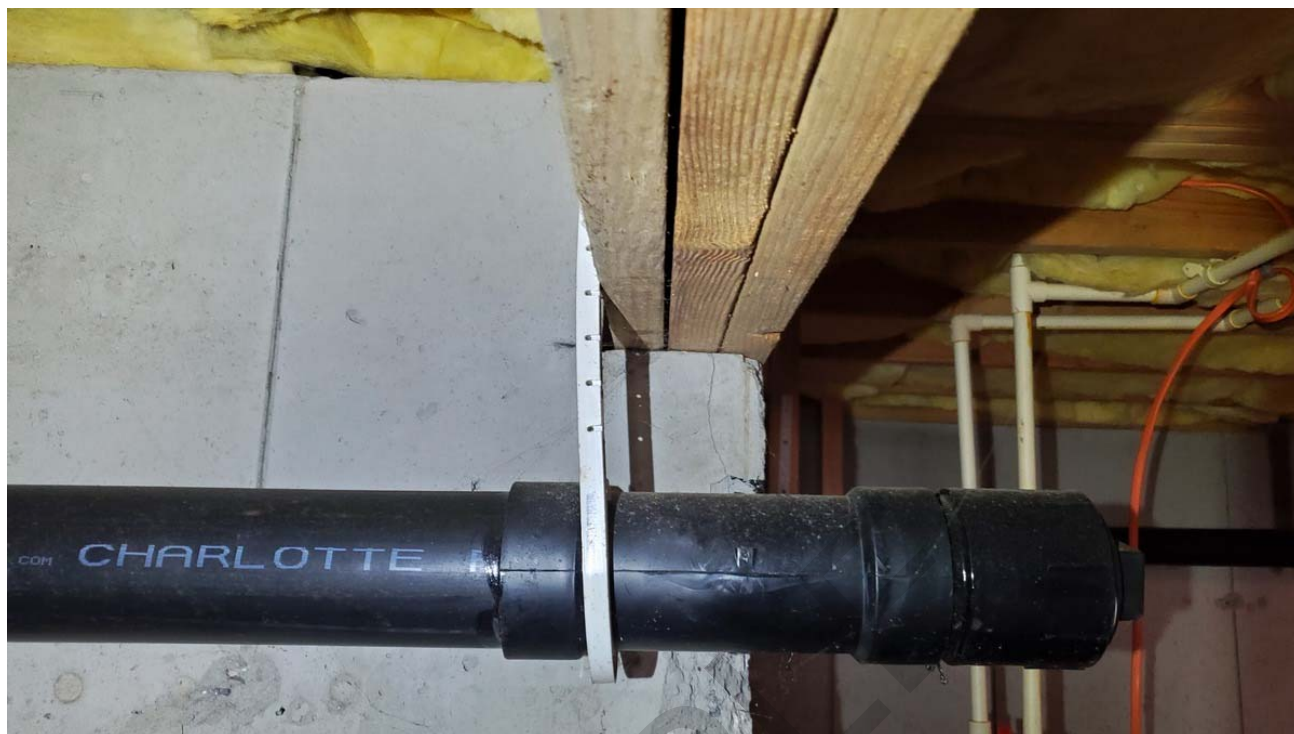
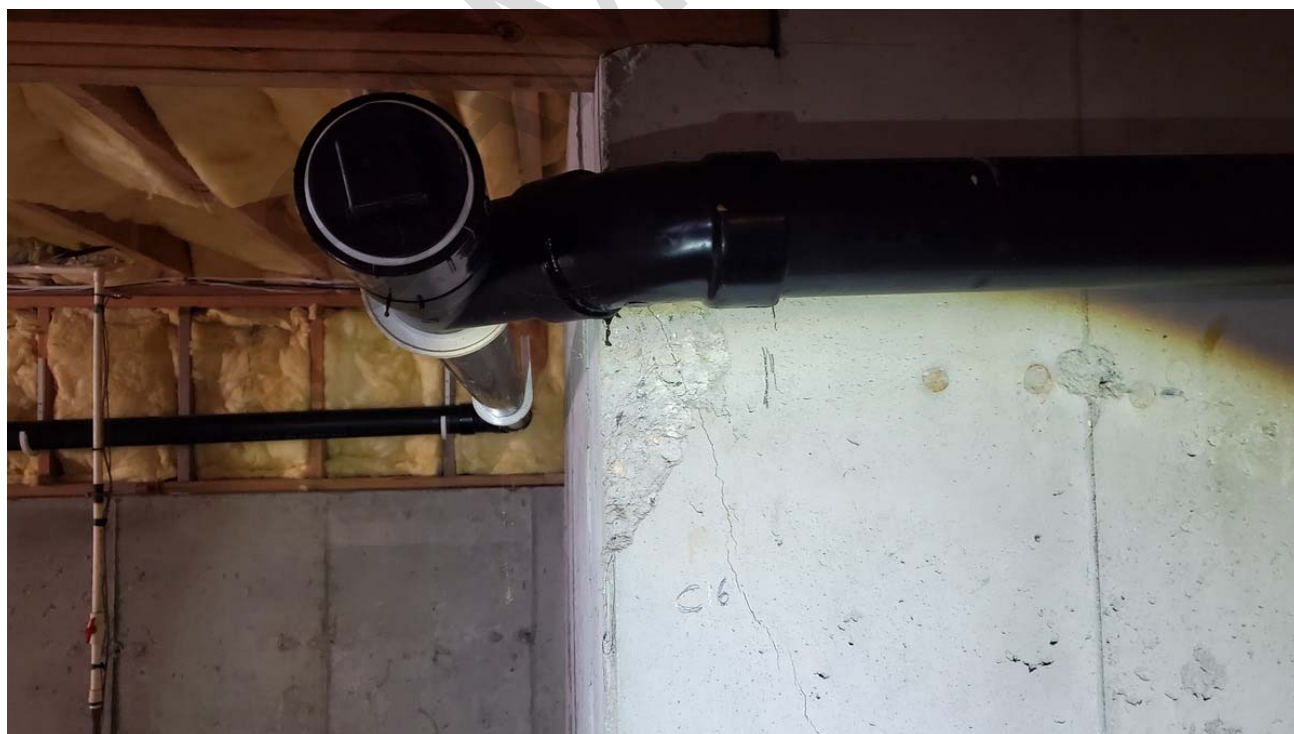
An additional crack of note exists beneath the southern beam pocket of the eastern-most beam in the basement. (Key Plan Observation #5) The inside corner of the foundation has been damaged at this location to facilitate plumbing installation. The concrete directly beneath the beam is cracked, and may not provide adequate support for the beam above.

Cracked beam pocket, eastern-most beam.

Additional view of crack at beam pocket, eastern-most beam.

The crack located beneath the beam pocket (Key Plan Observation Item #5) should also be epoxy injected as above, to restore integrity at this location. We additionally recommend the installation of a properly designed column and footing, as close as possible to the installed plumbing, to provide additional support for the beam above, as the beam pocket can no longer be relied upon for support.

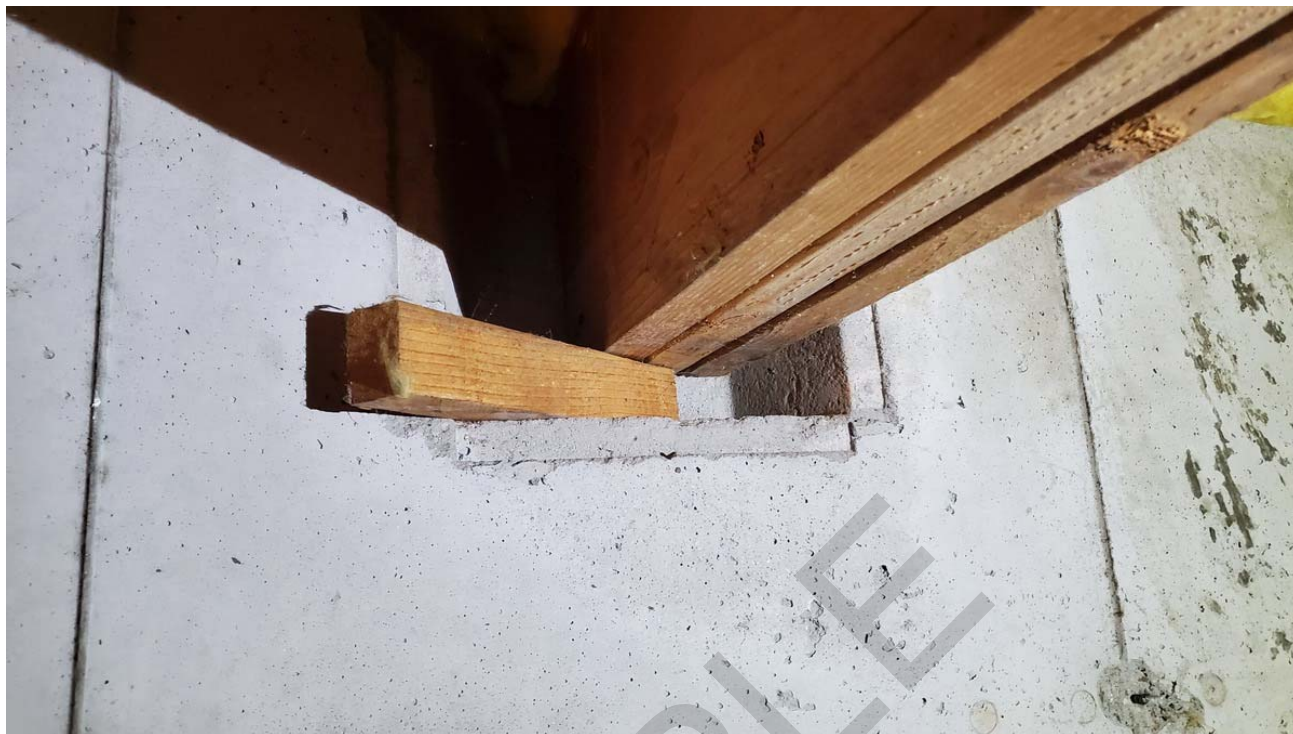
The shims beneath the south west beam in the basement are loose and do not provide adequate bearing. The shim beneath the southern end of the beam which runs alongside the basement stairs does not provide adequate bearing. (Key Plan Observation Item #4)

Loose shim at beam pocket, south – western beam.

Beams should be properly supported with either hardwood or masonry supports, providing full bearing between the beam and beam pocket. Installed shims should be secured in place.

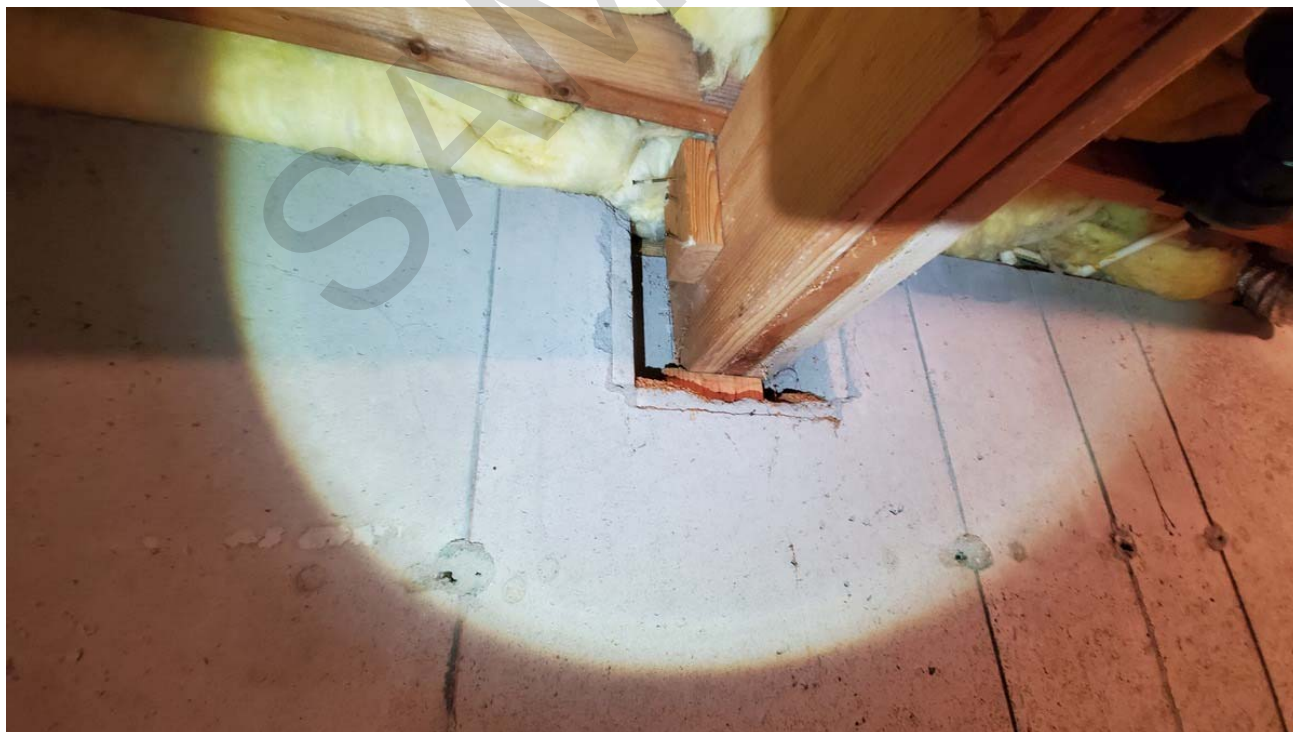
Inadequate bearing provided by shim, beam alongside basement stairway.

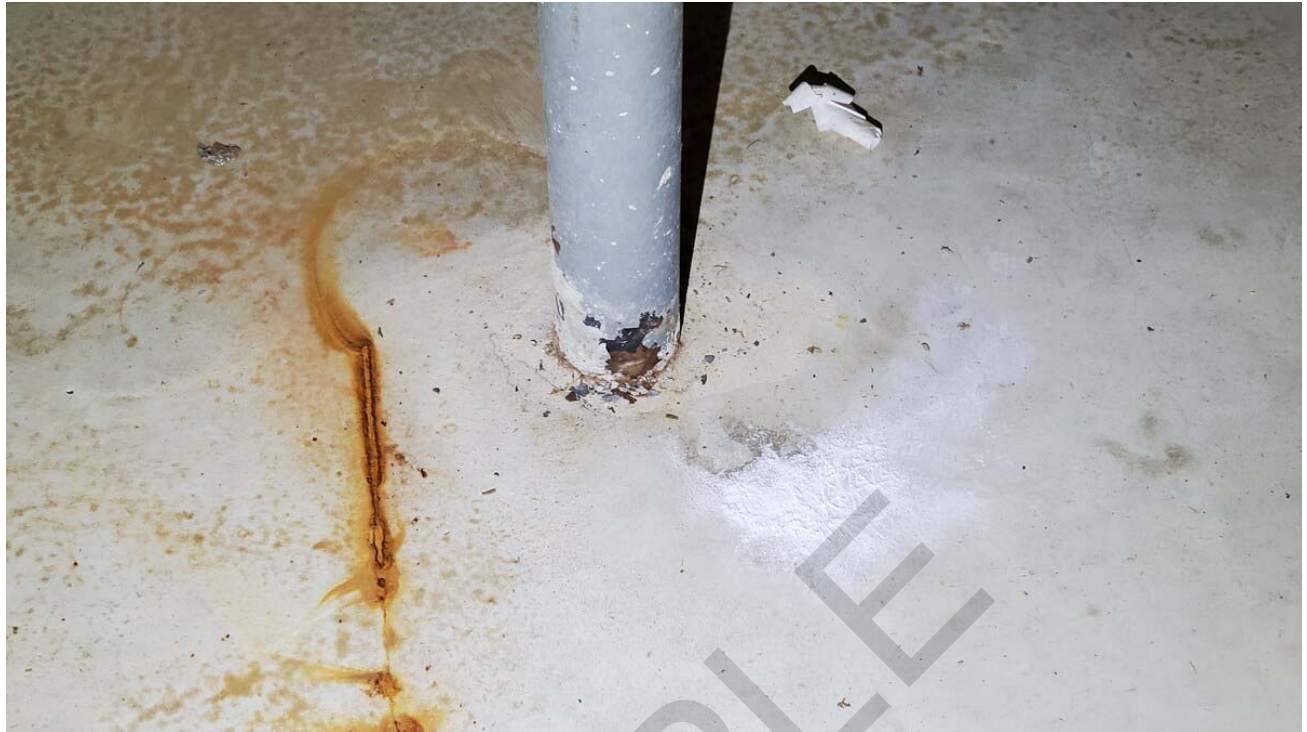
The bases of columns located in the basement area show signs of deterioration. Currently, this deterioration is surface level only, and has not compromised these columns. (Key Plan Observation Item #5)

Corrosion at column bases.

Columns in the basement should have surface rust removed, and be repainted to prevent further deterioration of these columns. This condition, if uncorrected, can cause eventual column failure.
