July 9, 2021

RE: Foundation Evaluation - xx xxxxx St., Mystic, CT

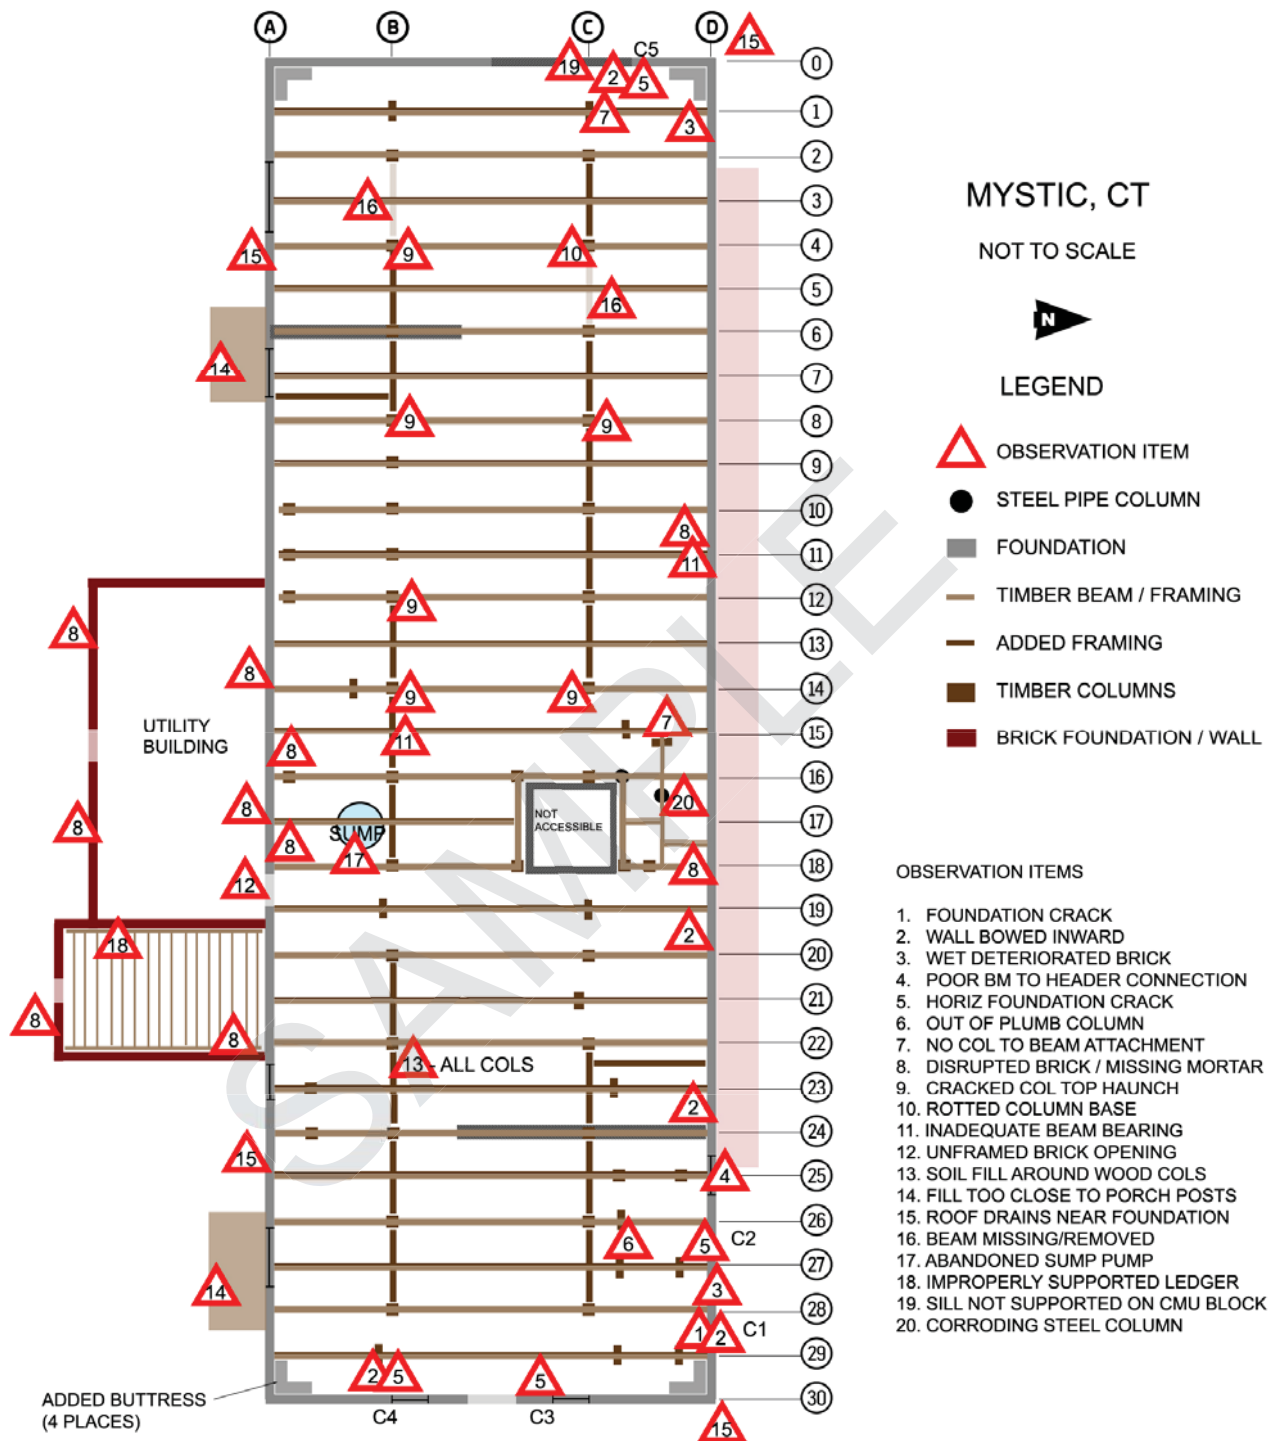
**KEY PLAN**

A number of cracks were observed in this foundation, their locations noted on our attached Key Plan (Key Plan Observation Items #1 and #5).

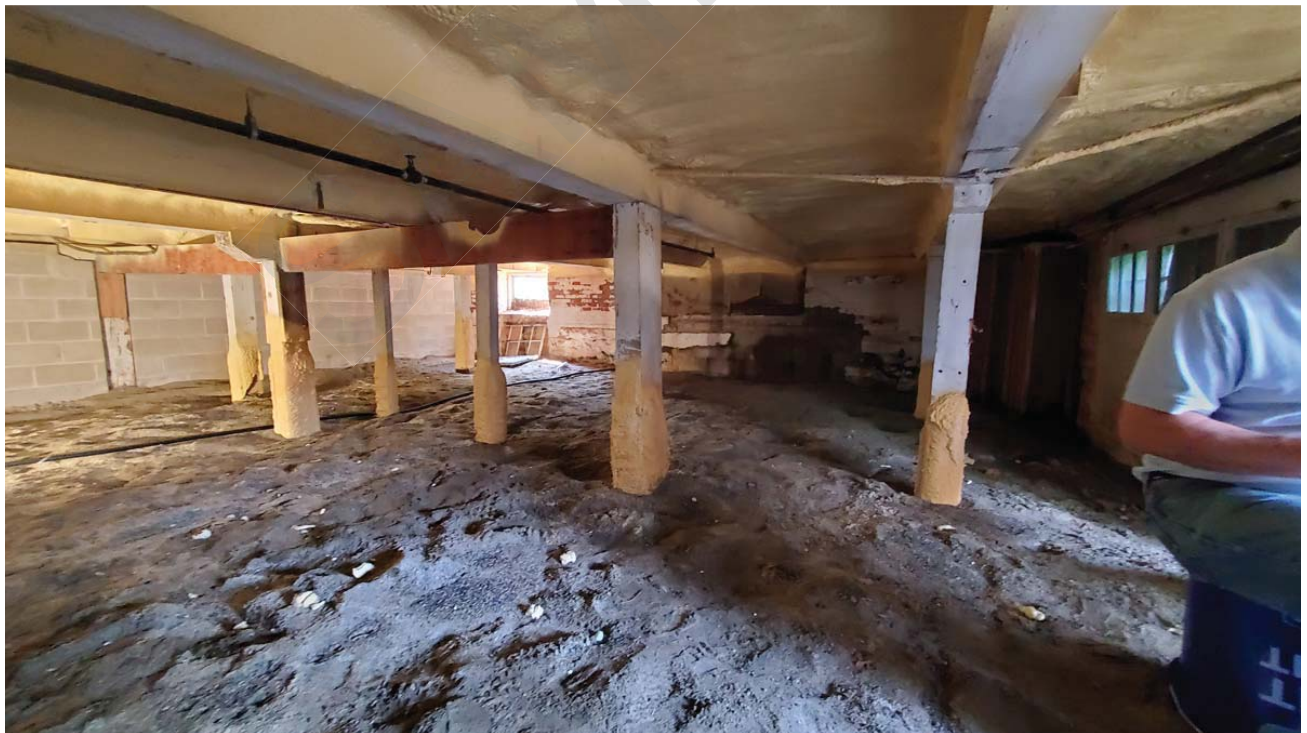
The initial significant observation upon entering the crawl space is that **the floor is a sand/gravel mixture that appears to have been added recently and surrounds each of the wood columns which disappear below grade** (Key Plan Observation Item #13). Further excavation revealed that approximately 24" or more of this sand and gravel have been added to the entire basement, perhaps in an attempt to raise the floor level to correct a moisture/water infiltration problem. The wooden columns below grade have been sprayed with a spray-foam insulation prior to backfilling with sand and gravel. Sampled portions of the foam insulation below grade were saturated with water. **This is highly unusual and will undoubtedly lead to rapid deterioration of the columns. The sprayed on insulation is not an appropriate or effective protection against water and moisture. This added sand and gravel also precluded inspection of the lower portion of the foundation walls.**

The first floor - floor framing is supported at the perimeter on the foundation walls to the interior atop timber columns. As discussed above, The wooden columns below grade have been sprayed with a spray-foam insulation and backfilled with 24” +/- of sand and gravel. **This is highly unusual and will undoubtedly lead to rapid deterioration of the columns.**

Added fill covers approximately 2' of the basement and surrounds the timber columns.

Far and above any other recommendation contained herein, we recommend the immediate correction of the added sand and gravel against the wood columns in the crawl space.

Either the gravel should be immediately removed allowing access for inspection and maintenance or, if this proves impractical, the below grade portion of each column be replaced by a more suitable material. One such way to accomplish this is to excavate around each column and build a CMU pier surrounding the wood column to above the new grade. The upper portion of the column can then be secured to the top of the new pier, allowing the lower portion to be abandoned in place. **We cannot state strongly enough the danger of leaving this unattended. Unchecked, this condition will undoubtedly lead to deterioration of the columns which support the floors above and eventual collapse. This should be corrected within the next year.**

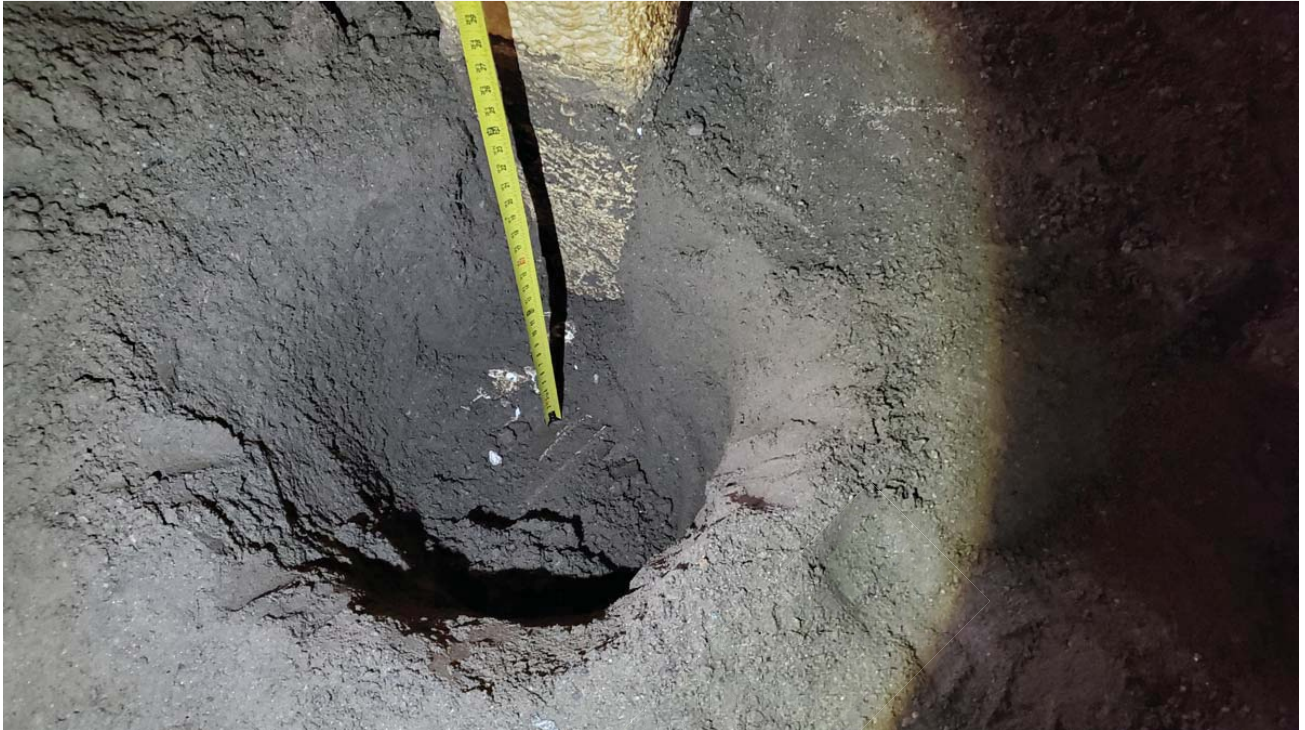
Excavation at the columns reveals 2' to the bottom of the original column.
Spray applied insulation was wet below grade.

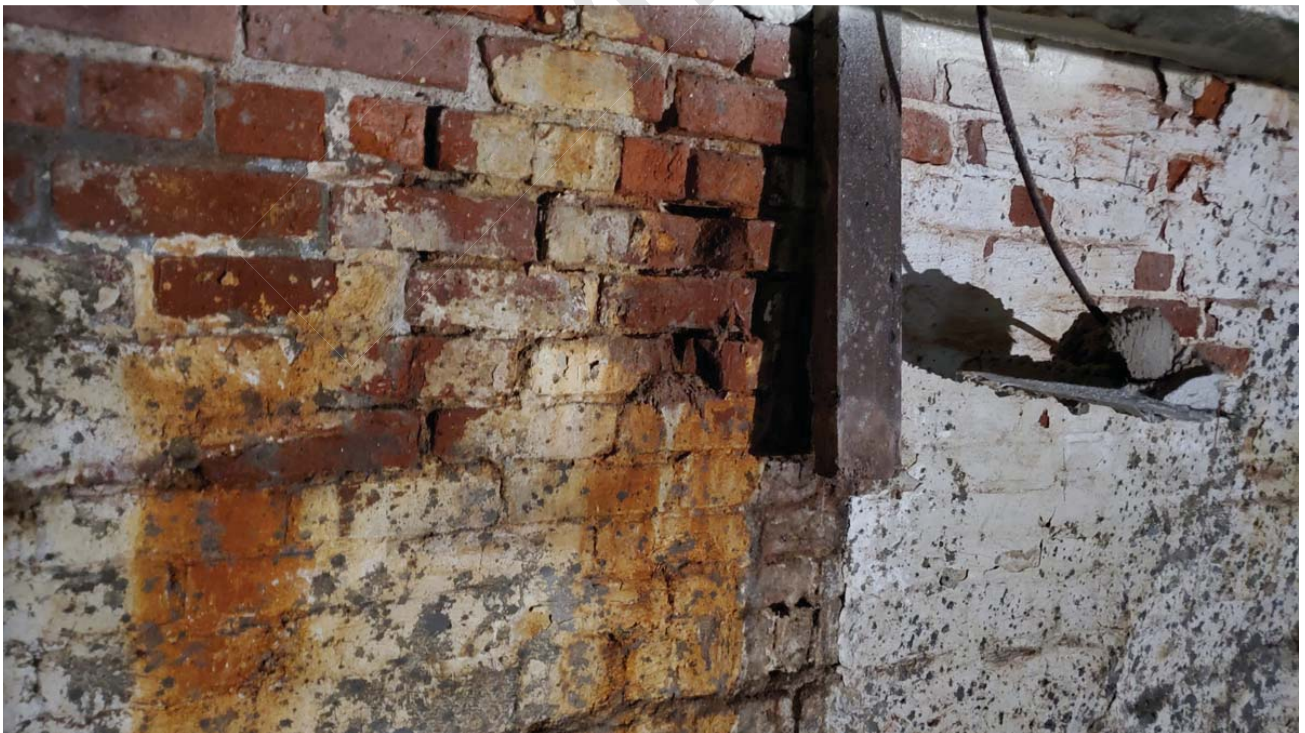
In addition to the horizontal cracks, **in at least 5 areas the brick portion of the foundation was observed to be bowing inward.** This almost always coincides with horizontal cracking. These are localized foundation wall failures due to deterioration and saturated soil pressure. (Key Plan Observation Item #2)

Some areas of the upper brick foundation walls were bulged inward due to soil pressure against deteriorated brickwork.

Horizontally cracked masonry and bulging brick walls should be either; excavated from the exterior to relieve pressure and then be rebuilt, or where that is not practical, have an interior concrete buttress installed to withstand the soil pressure.

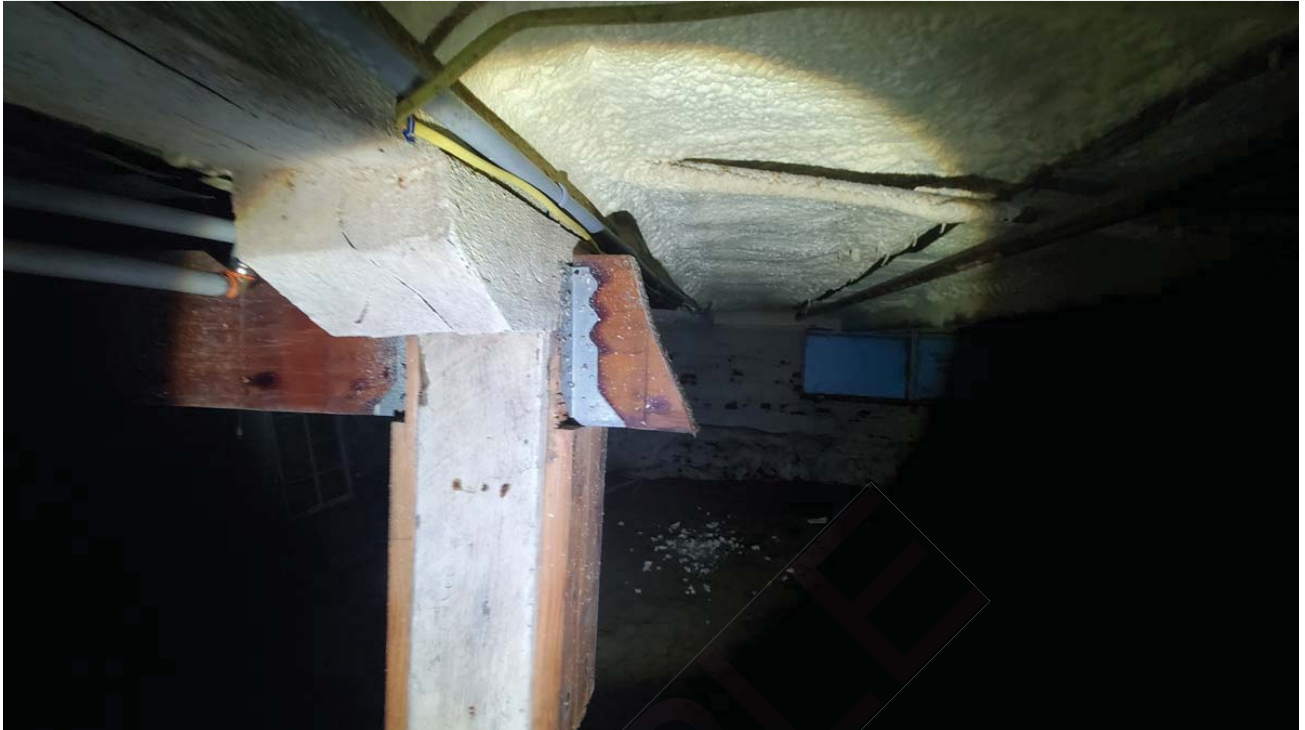
prevent crushing of the beam at that location. Some of these haunches were cracked or otherwise noticeably distressed (Key Plan Observation Item #9).

Wood haunches atop the timber columns were cracked in some locations.

Cracked haunches at the top of a small number of columns should be replaced with an appropriate timber. In lieu of this it is possible that some type of in-place reinforcement might be designed.

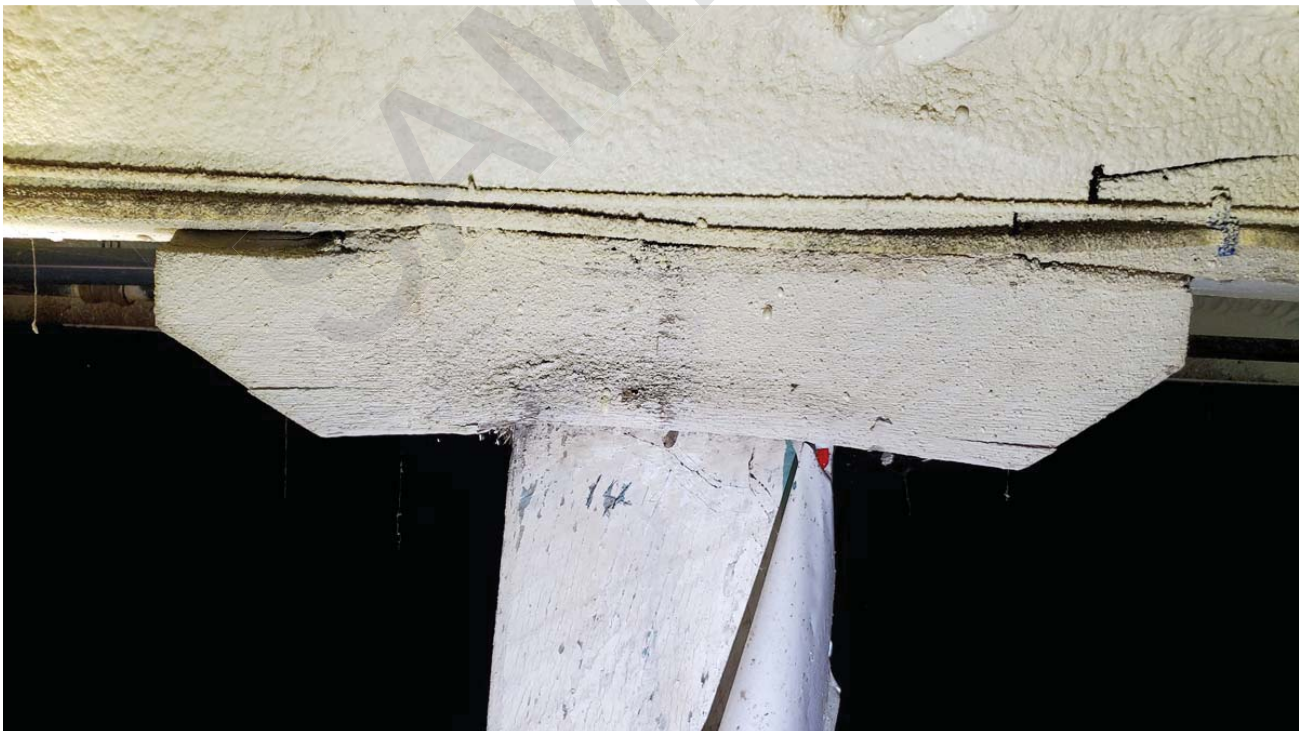
Other haunches were severely deformed due to compressive loads.

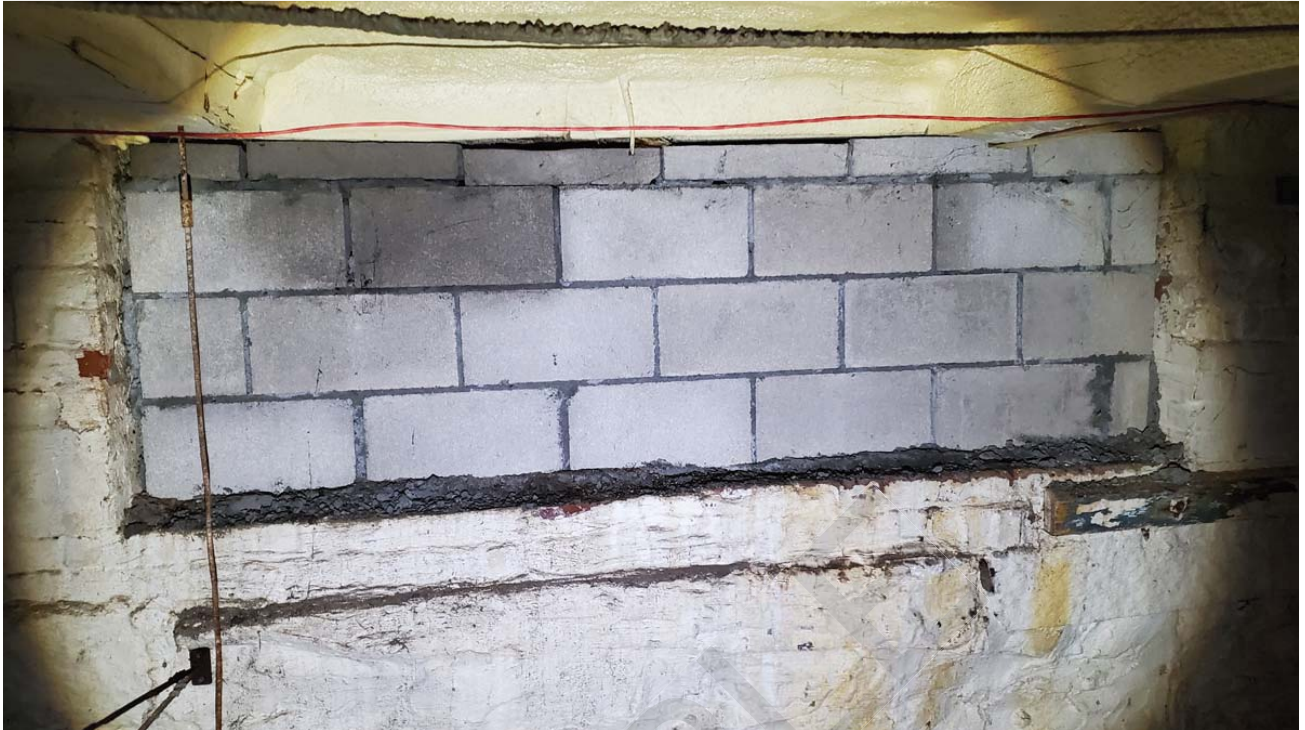
A section of the west end of the foundation has been replaced with concrete block (CMU) and that block section is not in contact with, and is not supporting the building sill as it should. (Key Plan Observation Item #19)

An added section of concrete block does not properly support the sill.

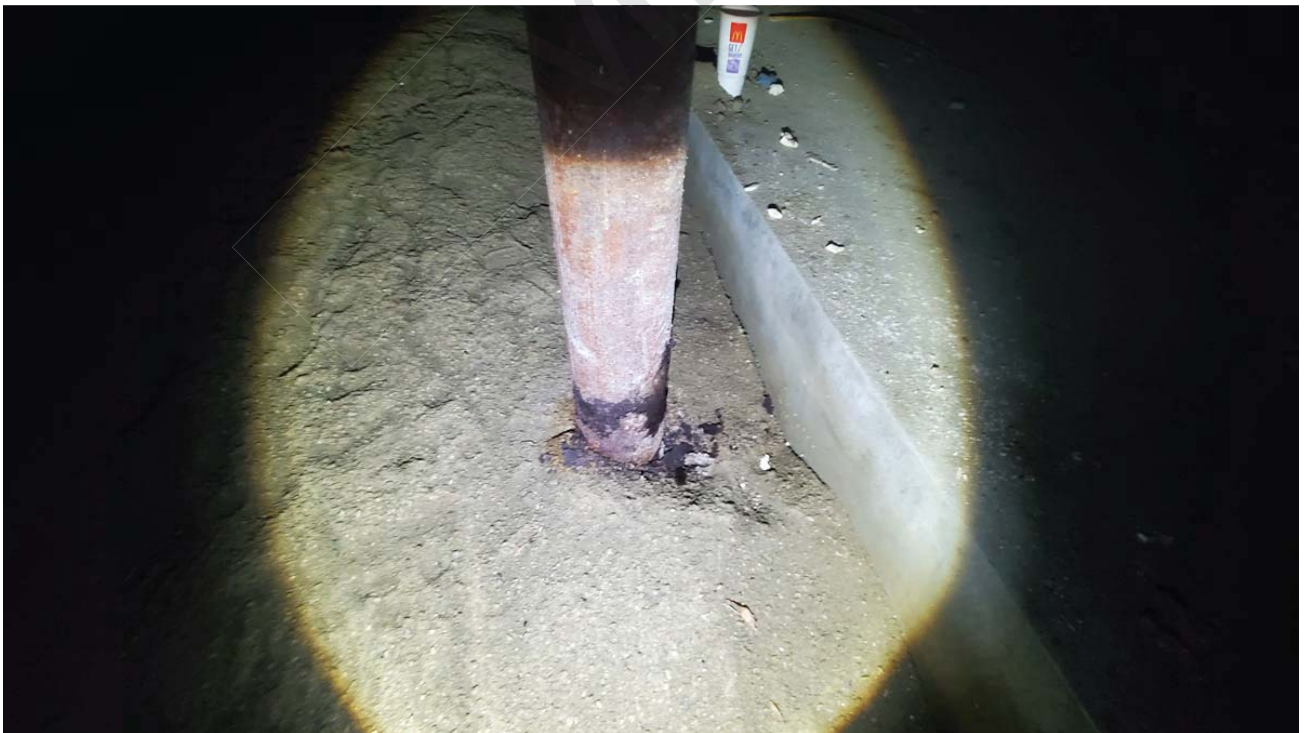
A steel column which disappears below the added soil is severely corroded due to contact with wet soils (Key Plan Observation Item #20).

Steel column is corroding due to its contact with damp soil.

The corroded steel column should be excavated and either the lower section be encased in a reinforced concrete pier or replaced entirely.

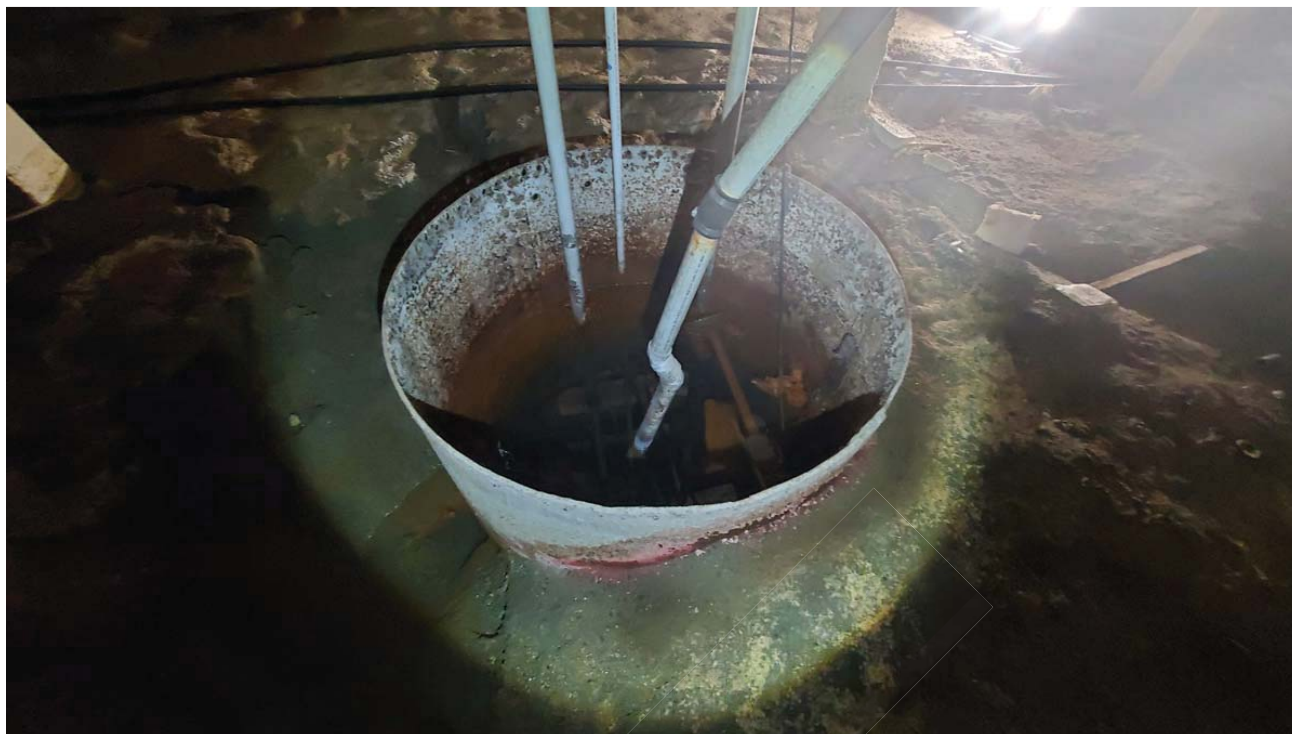
Dampness and evidence of moisture/water entry were observed throughout the foundation. A large sump pit exists in the center of the basement, however the pump was not functioning and appears to have been abandoned for quite some time. (Key Plan Observation Item #17)

Sump pit receives drain water from above. Pump abandoned and non-functioning.

The abandoned sump pump should be restored or additional sump pits/pumps be installed throughout the space once other corrections have been made. Additionally, a vapor barrier or new slab at the floor level should be considered once the sand/gravel is removed, or installed atop of it if it is to remain. If this is insufficient to control the high humidity, a dehumidifier is suggested.

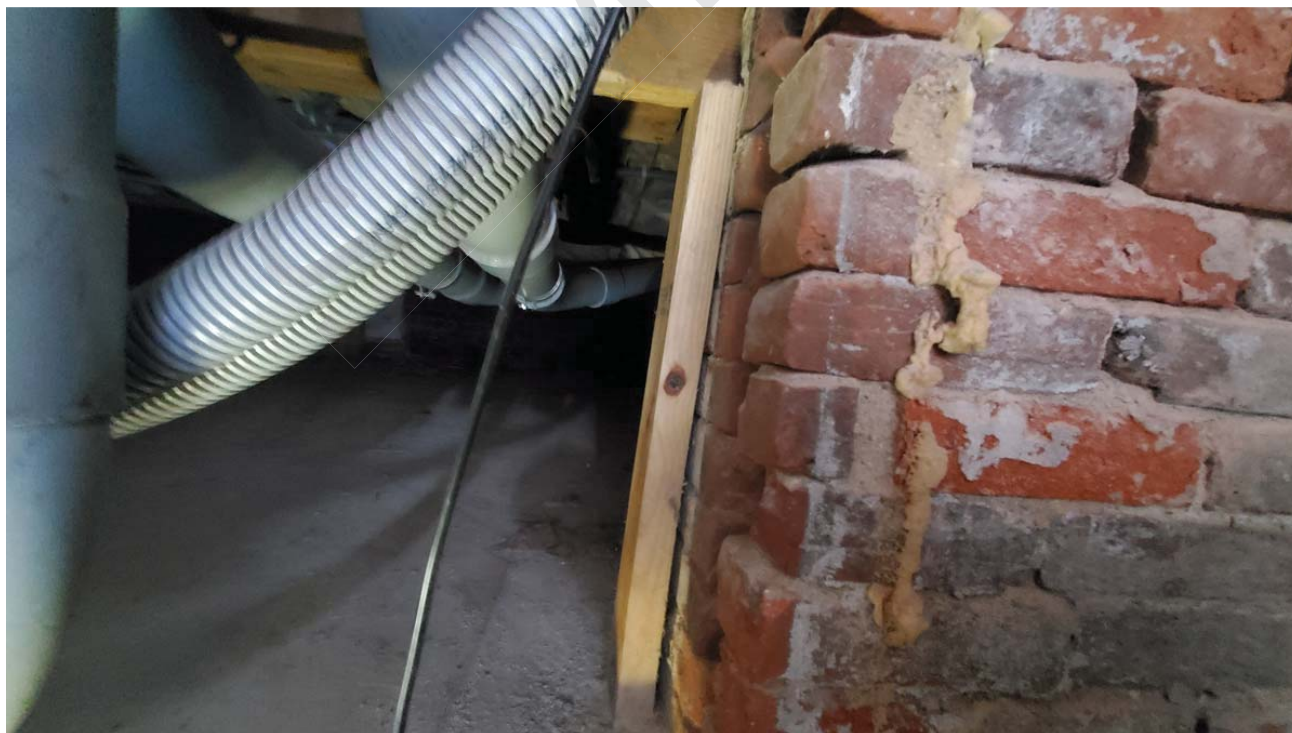
In the east portion of the utility building we could observe the underside of a floor system supported on ledgers attached to the brick and supported on posts. Immediately adjacent to the opening to this space the ledger is inadequately supported on a single 2x4.

Utility building floor system inadequately supported by 2x4 post.

The improperly supported ledger in the east section of the utility building should be re-supported on appropriately sized pressure treated posts.

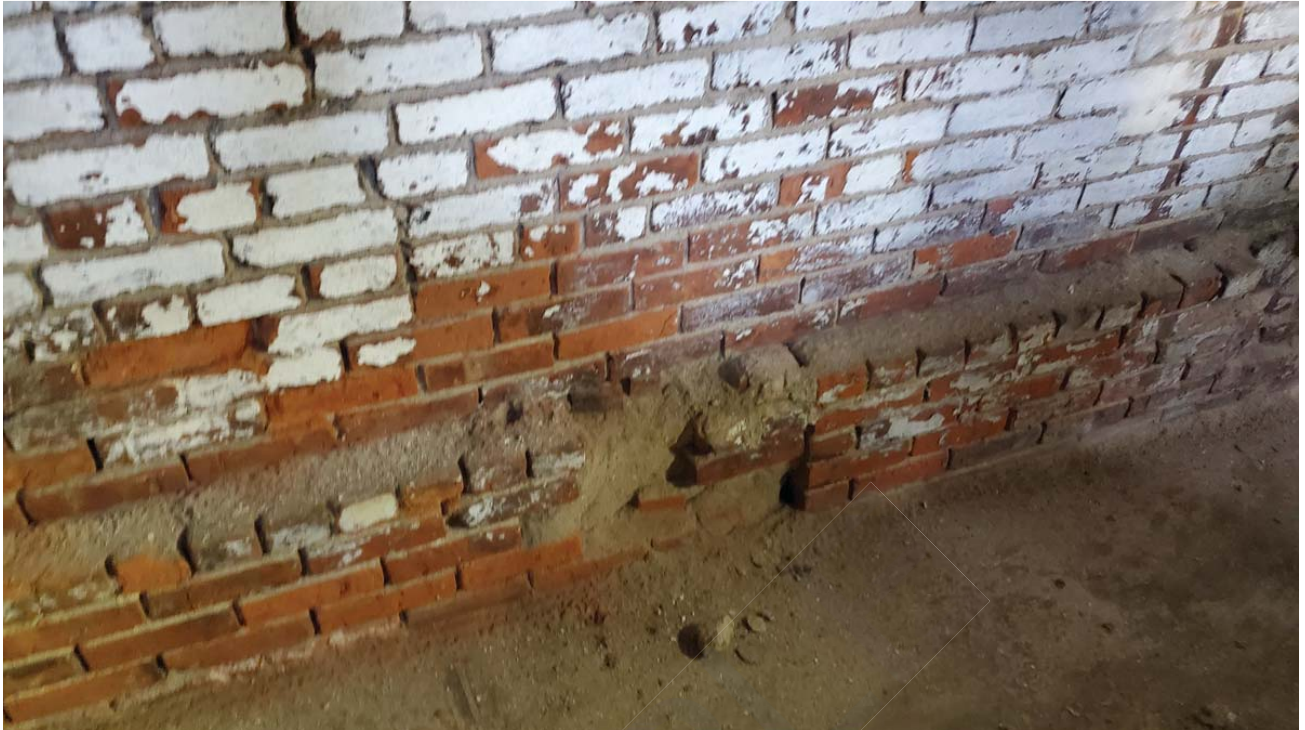
The visible foundation (and walls) of the utility building are brick both above and below grade. **There is a significant amount of brick deterioration and a number of areas of disrupted/displaced brick at the base of the walls and top of foundation** in this part of the structure. (Key Plan Observation Item #8)

Interior of Utility Building foundation has extensive deterioration to the brick and mortar.

Deteriorated brick and brick mortar joints should be repaired by a combination of replacement of disrupted areas and repointing of the surrounding areas.

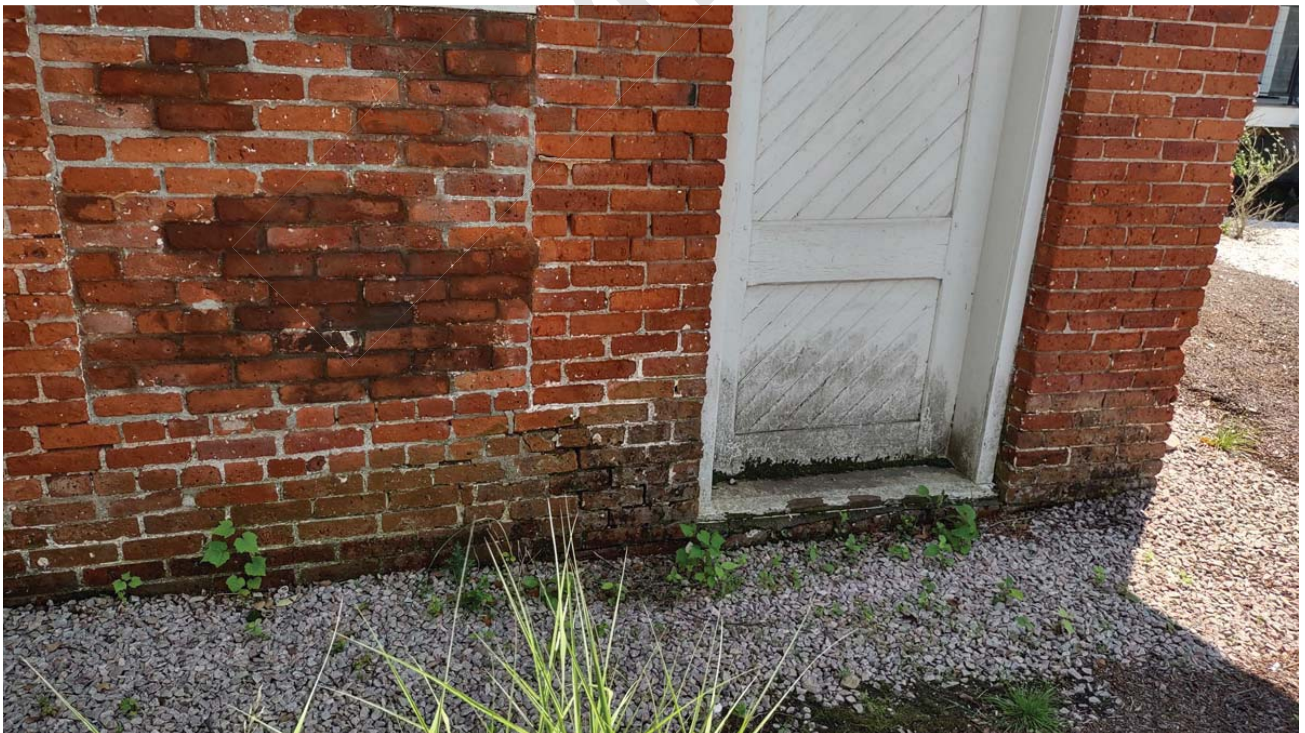
Exterior of Utility Building shows signs of severe mortar and brick deterioration at the foundation and further up the walls.

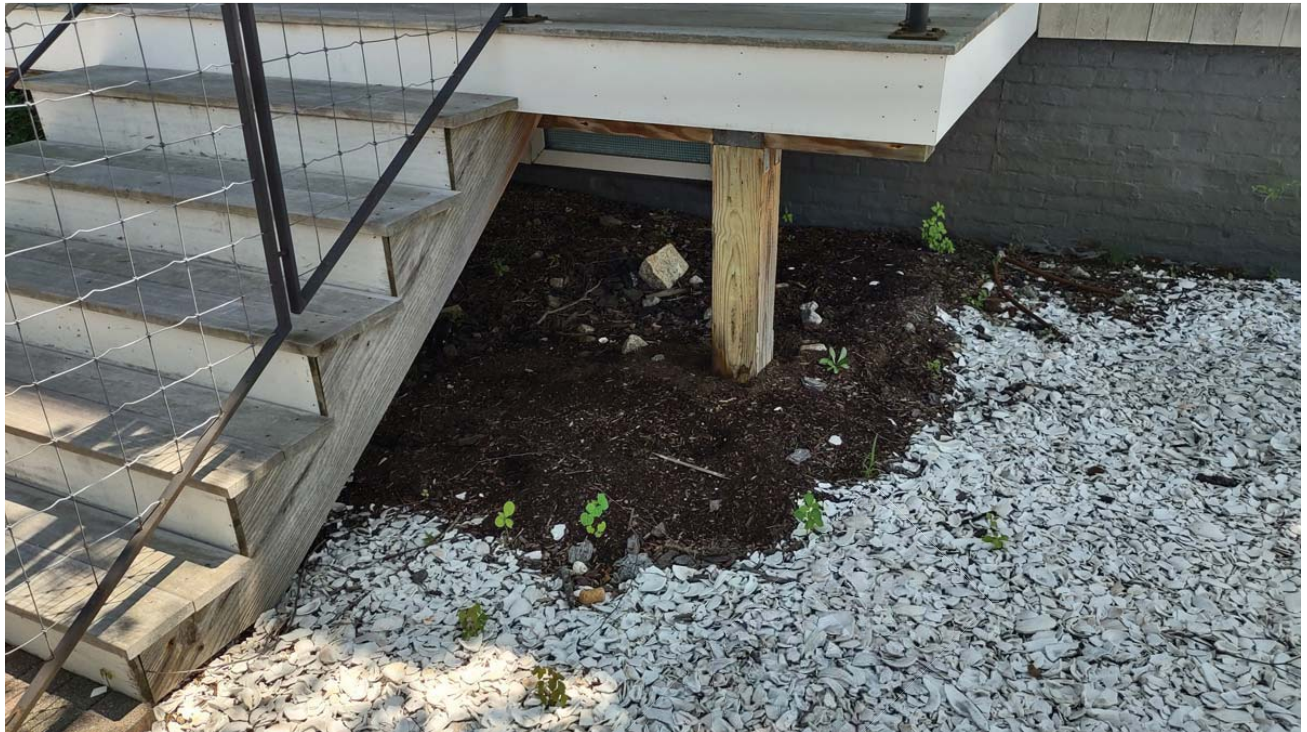
On the south face of the building two small entryway stairs and decks are supported by wood columns and concrete footings. Earth and landscaping mulch is either close to or in contact with the wood posts. This can lead to rapid deterioration of the columns. (Key Plan Observation Item #14)

Entry porch posts in contact with wet soil.

Soil against the entry platform columns should be graded to allow these posts to remain dry.

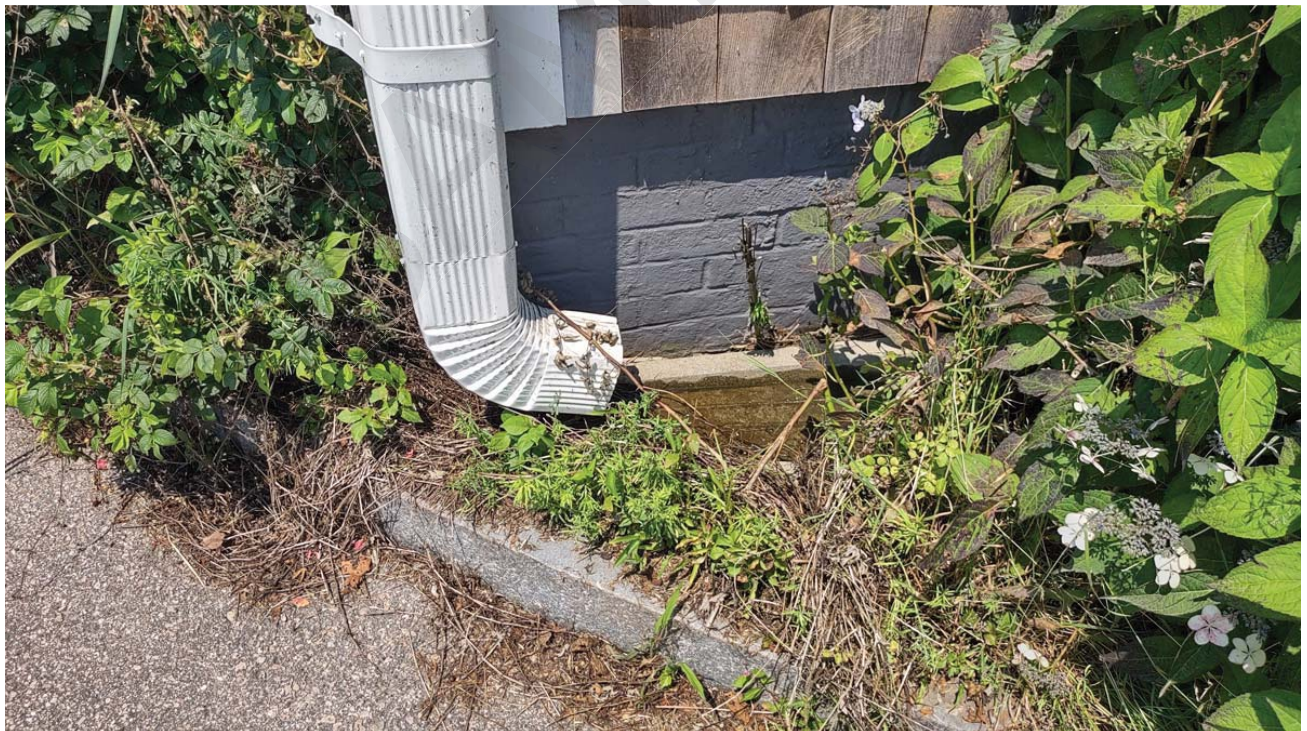
In many areas the grading around this structure is not ideal, low spots exist that may lead water to the foundation. In at least 2 locations downspouts discharge roof runoff extremely close to the foundation. The south side of the building had a notable lack of gutters and roof runoff again is deposited directly adjacent to the building foundation. (Key Plan Observation Item #15)

Poor roof drainage and downspouts lead runoff water directly to the foundation.

All installed drainage systems should be inspected and their functionality verified. Gutters and downspouts should be cleaned on a regular basis to ensure proper flow.

Site grading should direct rain water away from the house or structure. The landscape surrounding a house or structure should have a minimum of 5 ft. of "positive," or downhill, drainage away from the foundation, at a minimum of 5% slope. Modifications to grading will reduce the amount of water arriving at foundation walls, and reduce efflorescence.
