February 25, 2021

RE: 123 Autumn Lane - Anytown, CT.

On February 21, 2021 we visited the above referenced location to inspect the foundation of the existing residential structure - specifically the crack(s) noted during a recent home inspection. This inspection was limited to areas of the foundation that were viewable at the time of inspection. The following are our findings:

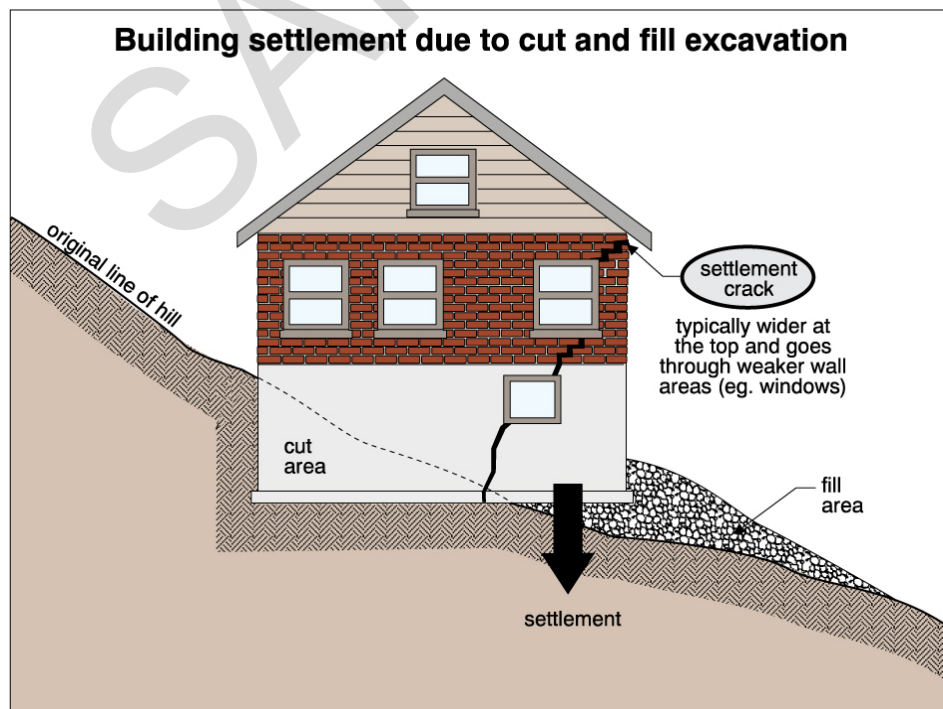
When a sloped lot is contoured for building, a “cut & fill” method is often used to create a flat terraced section of land suitable for building. A portion of the hill is cut, and the material is used to fill the lower elevation, creating a flat area. This cut material is typically re-compacted in its new location, however it is may not be as stable as the virgin, undisturbed soil beneath the other areas of the structure. The topography of this site suggests that this was the case at this location.

In this case, the settlement is likely due to improperly compacted soils. After the foundation is poured the weight of the concrete and structure above consolidates the soil over time until compaction is reached. Settlement caused by consolidation of foundation soils may take weeks, months, or years to be considered "complete."
